PROJECT ADMINISTRATION DATA SHEET

Sponsor U.S. Agency for International Development

Title Prototype Development and Technical Assistance to the USAID/Dominican
Republic Health Sector II Project

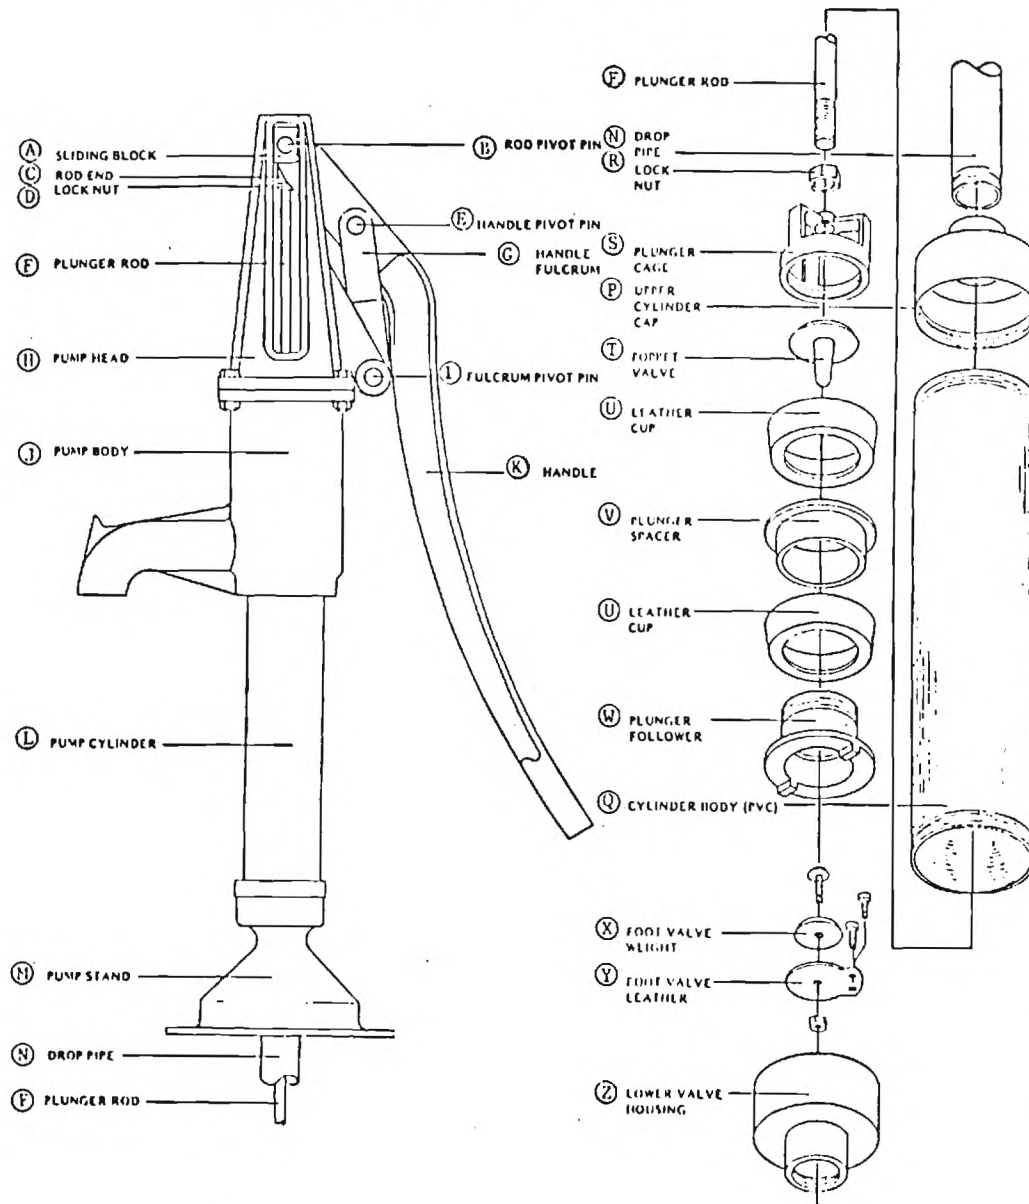
Figure 4

AID HAND PUMP PROBLEM AREAS

PART	COMMON PROBLEMS
A	
B	Pins and bushings not properly hardened
C	
D	
E	Pins and bushings not properly hardened
F	
G	Breakage in fulcrum clevis
H	
I	Pins and bushings not properly hardened
J	Poor threading in pump body
K	Breakage in handle clevis
L	Poor threading on pump cylinder
M	Poor threading on pump stand
N	
P	Poor threading on cylinder cap
Q	
R	
S	Breakage in plunger cage
T	Poor sealing surface on poppet valve
U	
V	
W	
X	
Y	Foot valve leakage and breakage
Z	Poor threading on valve housing

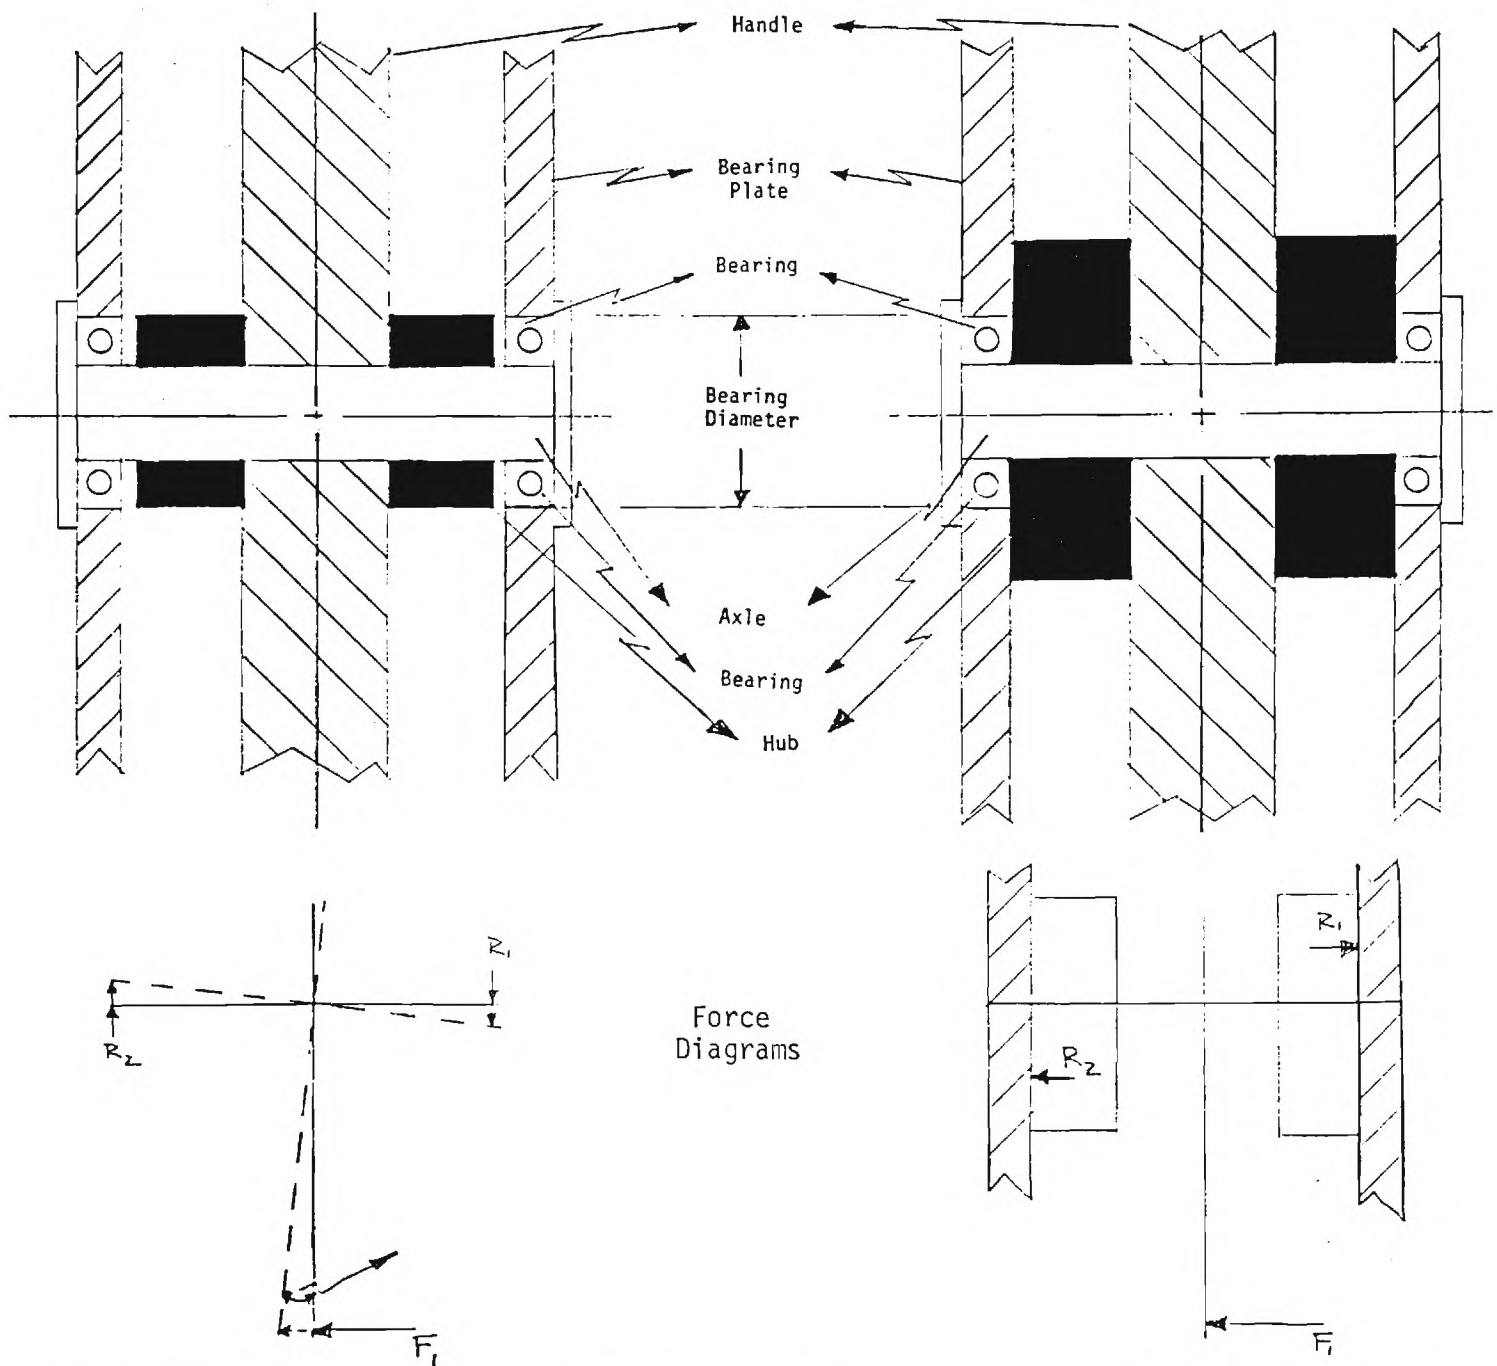
Figure 7
Section View of Handle
Bearing Area Illustrating Importance
of Hub Diameter

This pump performed flawlessly until the week of February 6, when the ball bearings supporting the handle axle failed. This failure was anticipated because of a design error in the hub diameter on the handle noticed during installation. (See Figure 7.) The outside diameter of the ball bearings used in the four prototypes was 1.125 inches, so the hub diameter should have been 1.750 inches. The "face-to-face" dimension of the hubs should

Note that hubs and bearings are same diameter and that handle side play is possible permitting axle to exert non-radial force on bearings.
